Fremantle Ports Inner Harbour Maintenance Dredging

Dredging Environmental Management Plan Compliance Report

REPORT NUMBER: R240150

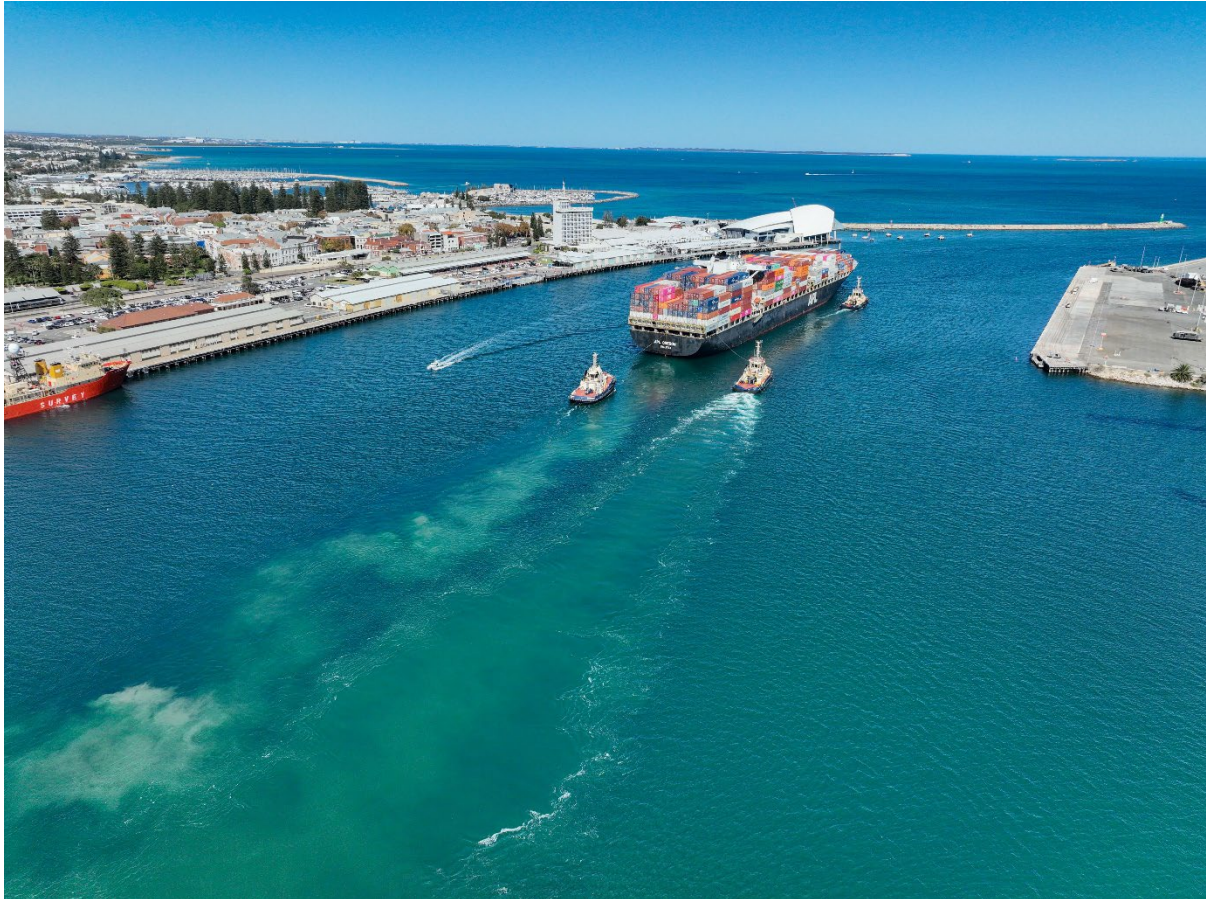
The Fremantle Port waters are an active waterway with high commercial and recreational traffic occurring often throughout pre-, during and post- dredging activity. This activity can contribute to suspended sediments in the water column and present similar to a dredging plume, causing a false interpretation of light levels and/or plume and water clarity results. This scenario can be observed in Figure 4.

Figure 4: Drone aerial image from Zone 1 on 16/04/2024 showing a visible sediment plume created by a ship exiting the Inner Harbour.

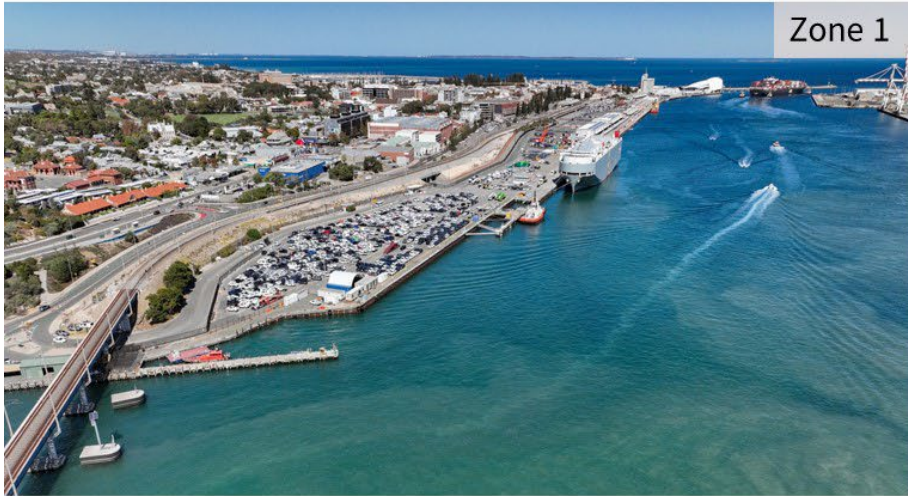
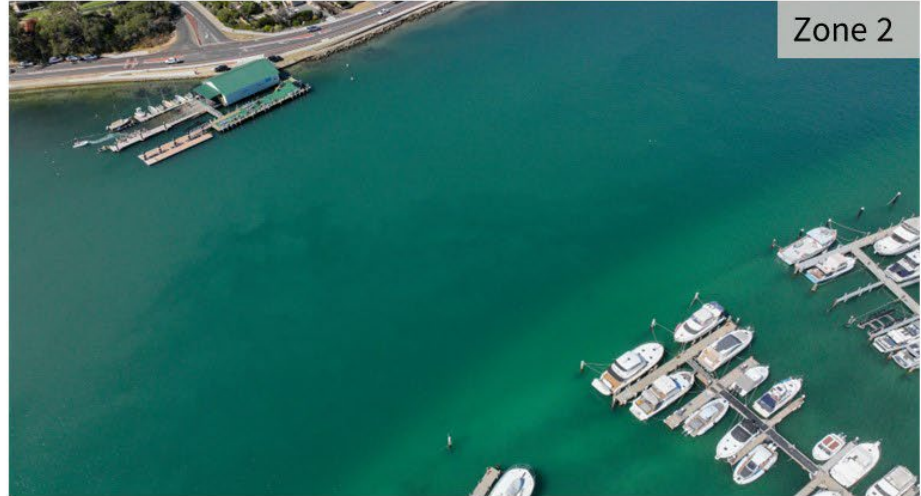
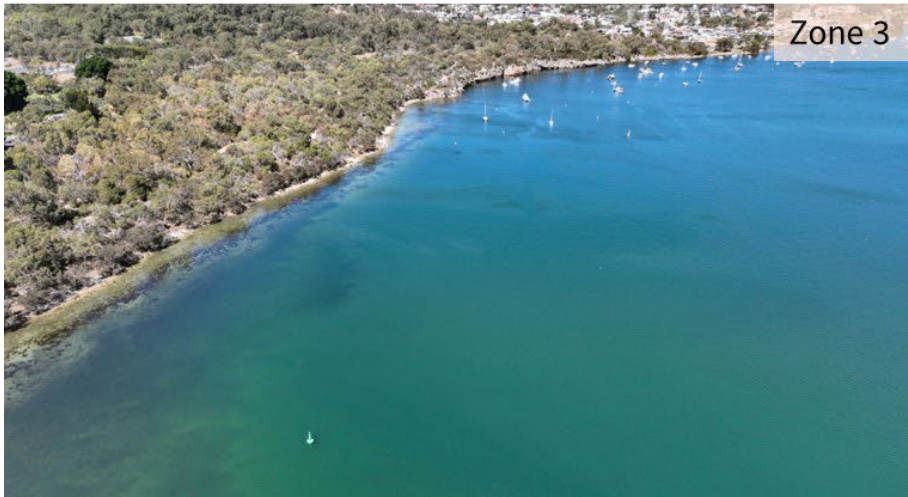
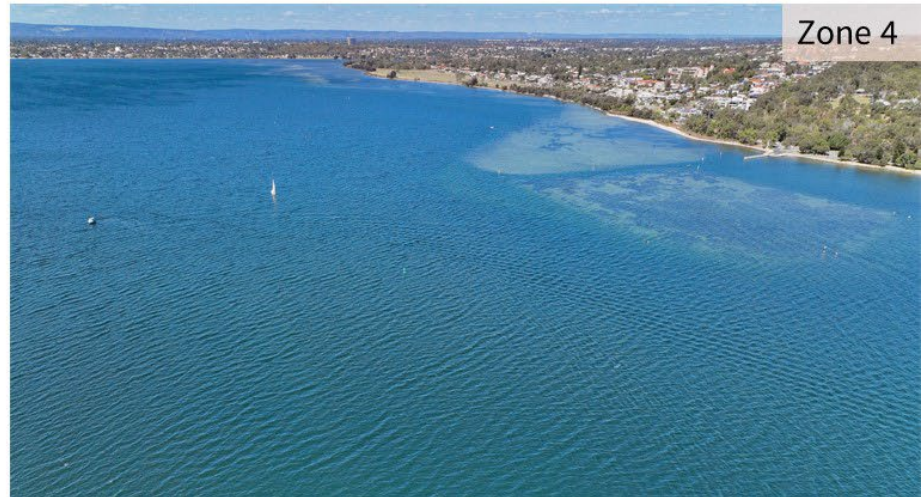
- On Day 2 a sediment plume was observed east of the Inner Harbour at Stirling Bridge (Appendix A, Figure 6, Zone 2).
- On Day 5 a sediment plume was observed in the Inner Harbour (Appendix A, Figure 7, Zone 1) and west of Point Walter (Appendix A, Figure 7, Zone 4).
- On Day 10 a sediment plume was observed east of Bicton Baths (Appendix A, Figure 8, Zone 3).
- On Day 15 a sediment plume was observed entering Freshwater Bay (Appendix A, Figure 9, Zone 4).
- No sediment plumes were observed in post dredge monitoring on 14 May (Appendix A, Figure 10 all Zones).

- On Day 2 a sediment plume was observed east of the Inner Harbour at Stirling Bridge, there were no TSS exceedances at any Swan River site however Secchi disc exceedances occurred at DR2, SI1 and SI3 indicating sediments had begun moving upstream from the Inner Harbour.

Figure 7: Drone aerial imagery from Day 2 - 16/04/2024

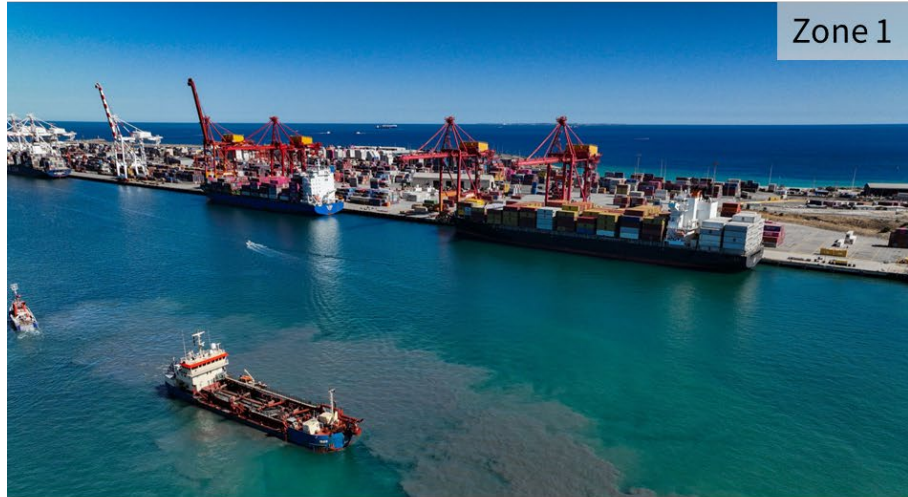
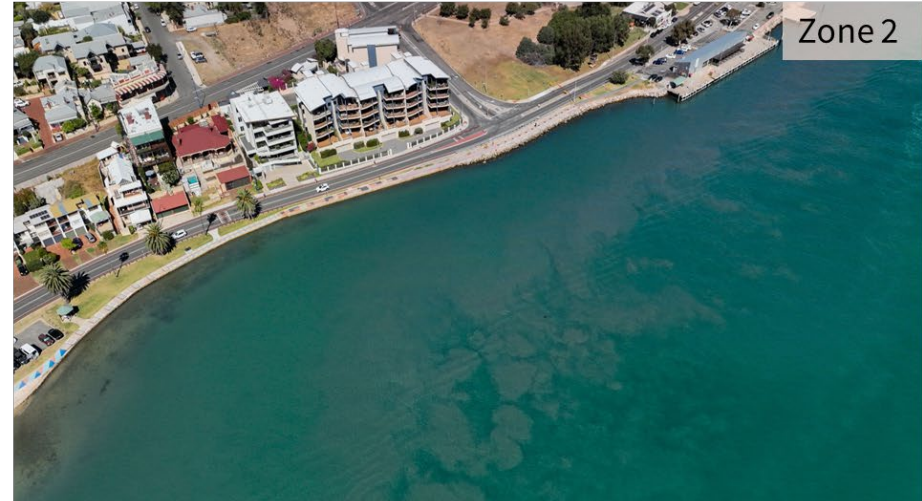
- On Day 5 a sediment plume was observed west of Point Walter. TSS exceedances occurred at Swan River impact sites SI1 and SI3 and Secchi disc exceedances occurred at DR2, SI1 and SI3 in line with visible sediment plumes.

Figure 8: Drone aerial imagery from Day 5 - 19/04/2024

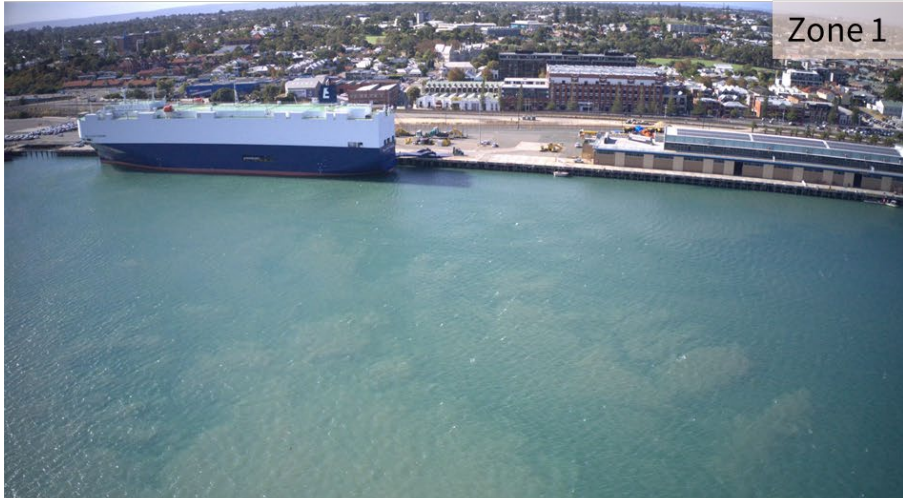
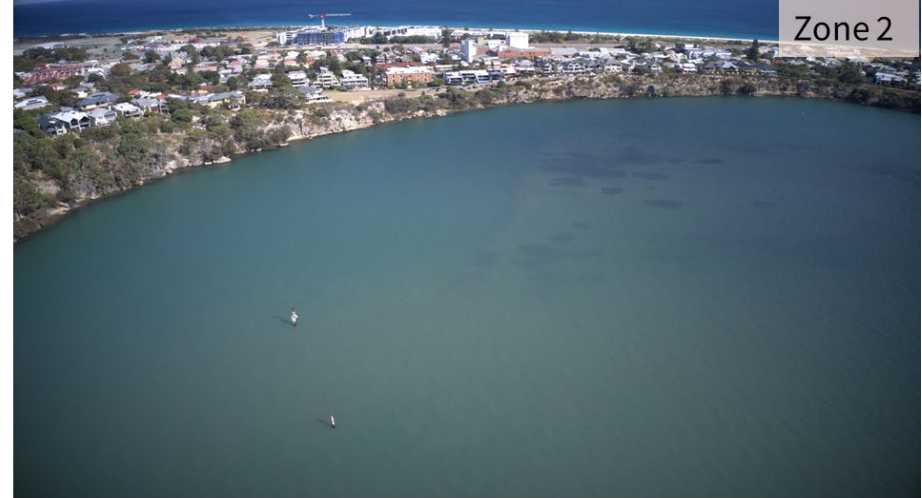
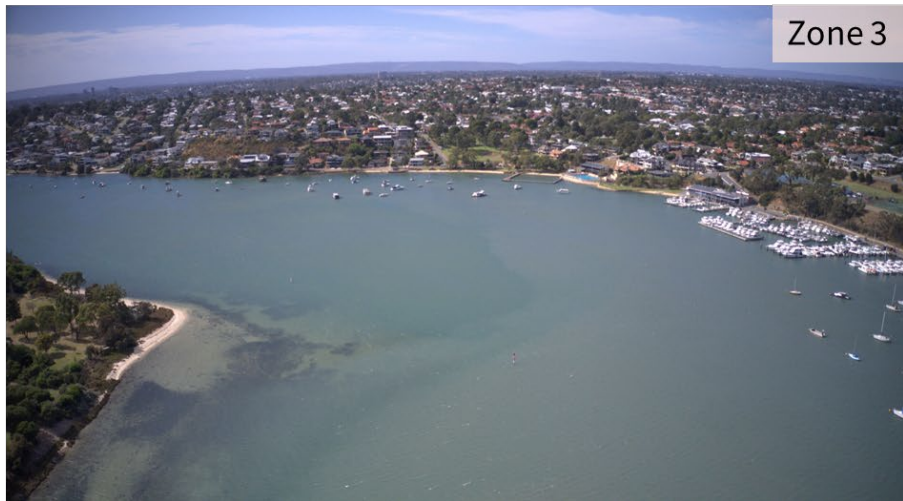
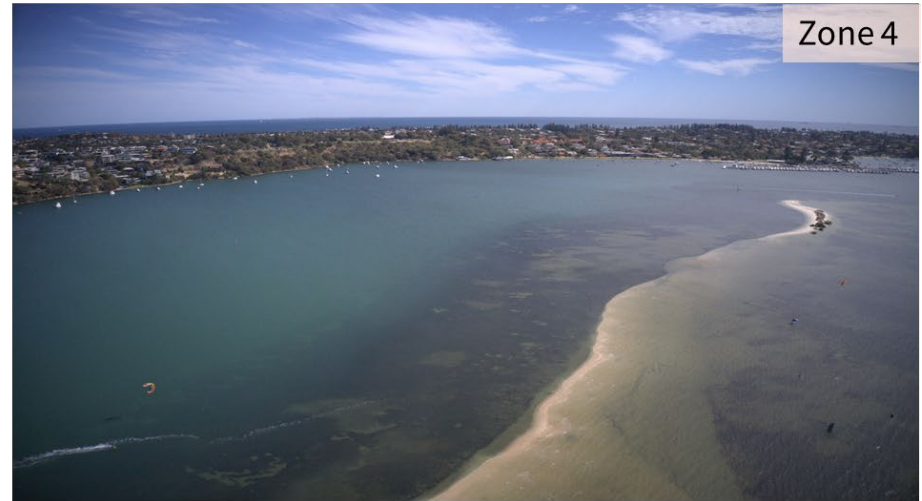
- On Day 10 a sediment plume was observed east and west of Bicton Baths. TSS exceedances occurred at Swan River impact sites DR1, SI1, SI2 and SI3 and Secchi disc exceedances occurred at all sites in line with visible sediment plumes.

Figure 9: Drone aerial imagery from Day 10 - 24/04/2024

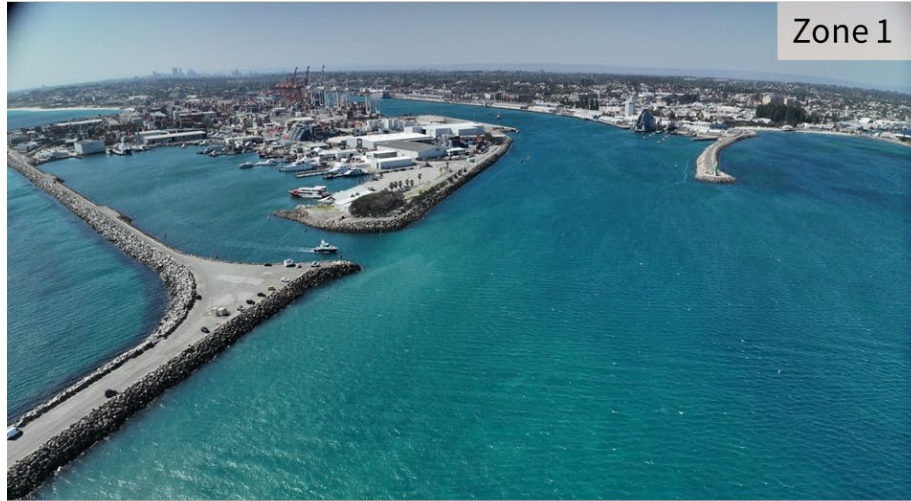
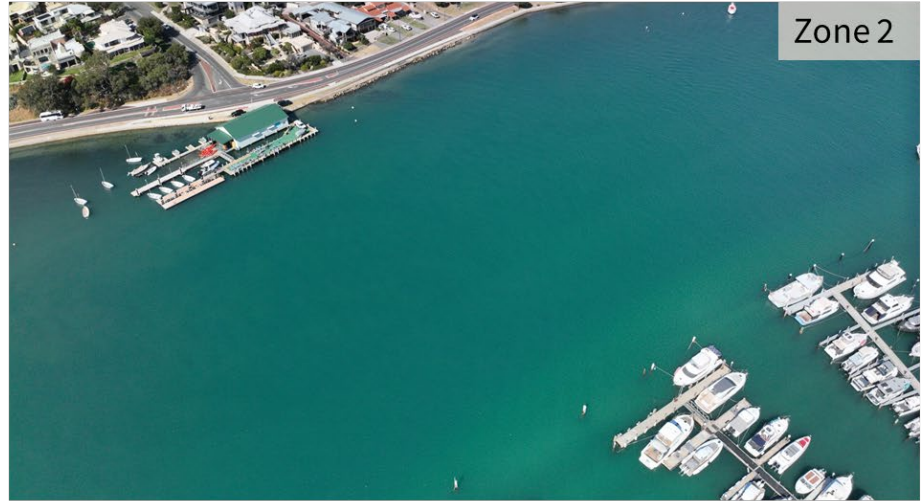
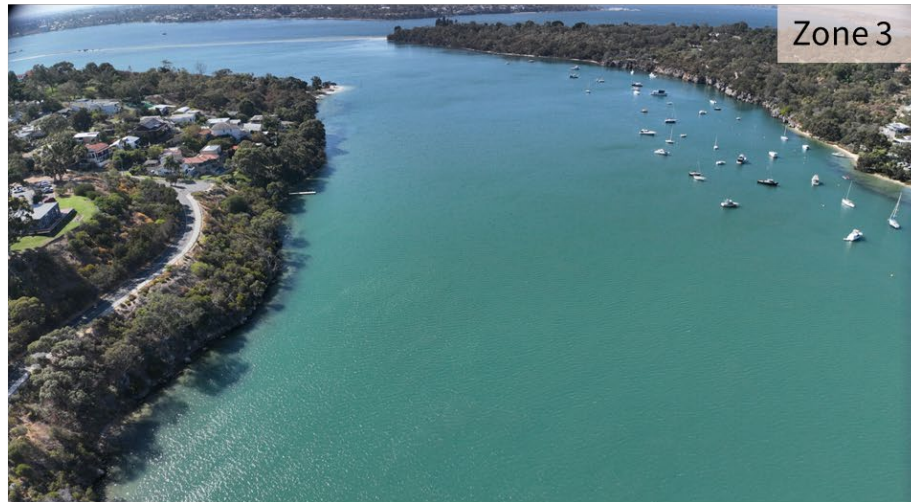
- On Day 15 a sediment plume was observed entering Freshwater Bay. TSS exceedances occurred at Swan River impact sites DR1 and SI3 and Secchi disc exceedances occurred at all sites in line with visible sediment plumes. Swan River reference site SR water clarity (Secchi Disc) was reduced on Day 10 and 15 therefore may have been impacted by the sediment plume entering Freshwater Bay however no reduction in TSS occurred at this site.

Figure 10: Drone aerial imagery from Day 15 - 29/04/2024

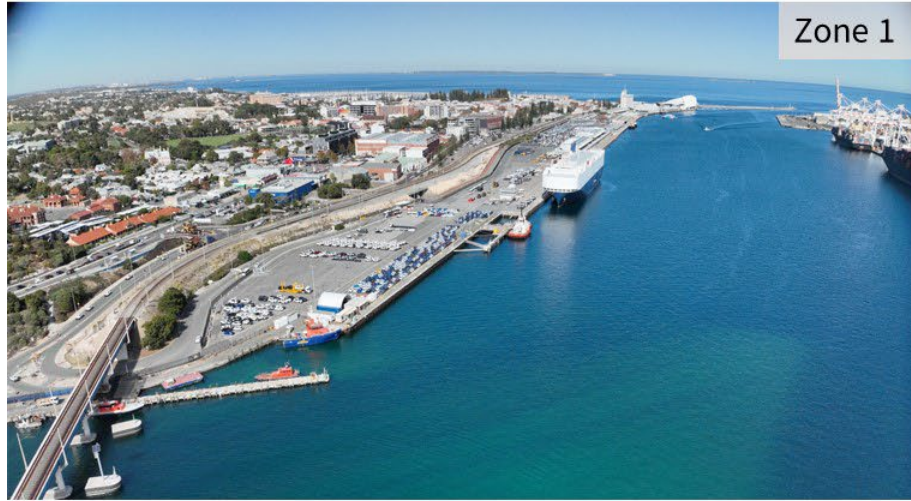
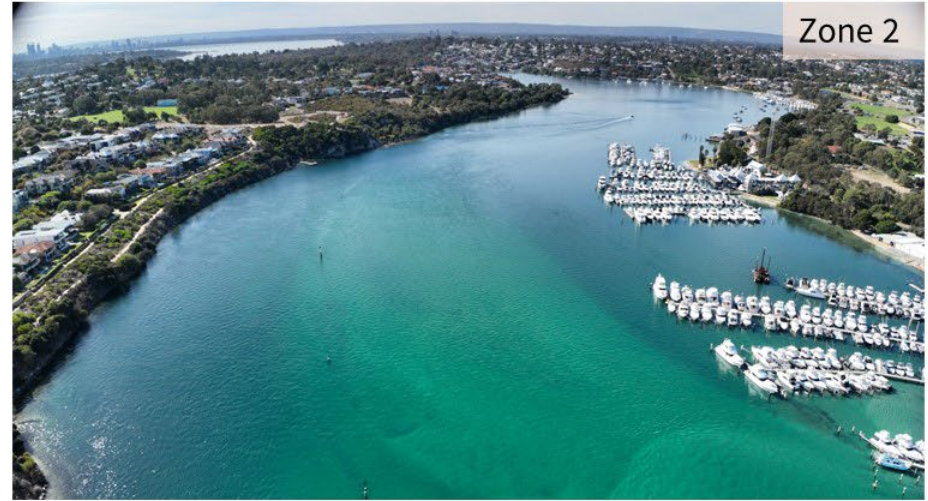
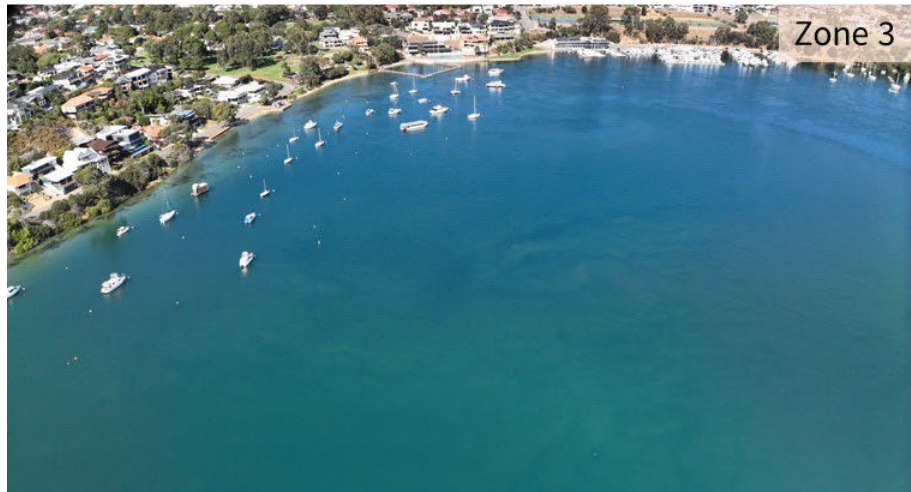
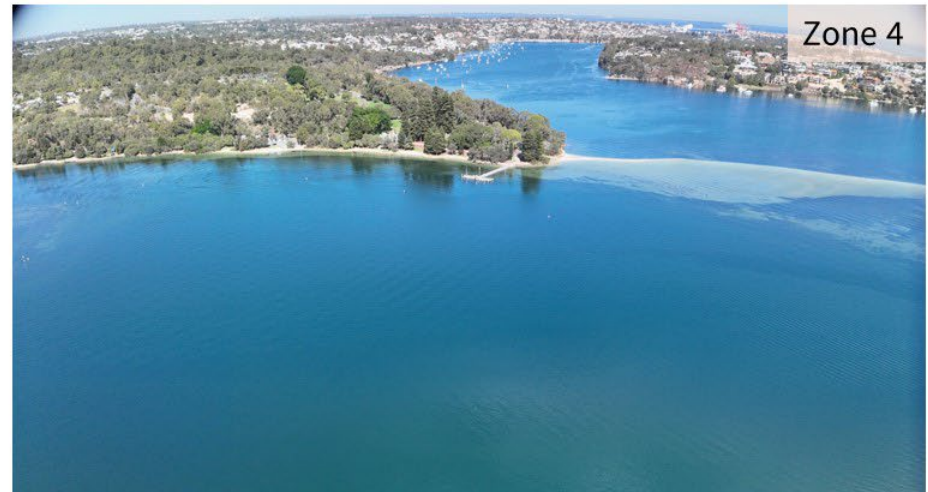
- No sediment plumes were observed in post dredge monitoring on 14 May. Except for S1, there were no Secchi disc exceedances at Swan River impact sites, in line with the absence of visible sediment plumes. TSS exceeded the environmental criteria (<80th percentile) however exceedances were not attributed to sediment plumes from dredging activity (refer section 3.2.2).

Figure 11: Drone aerial imagery from Post dredging - 14/05/2024

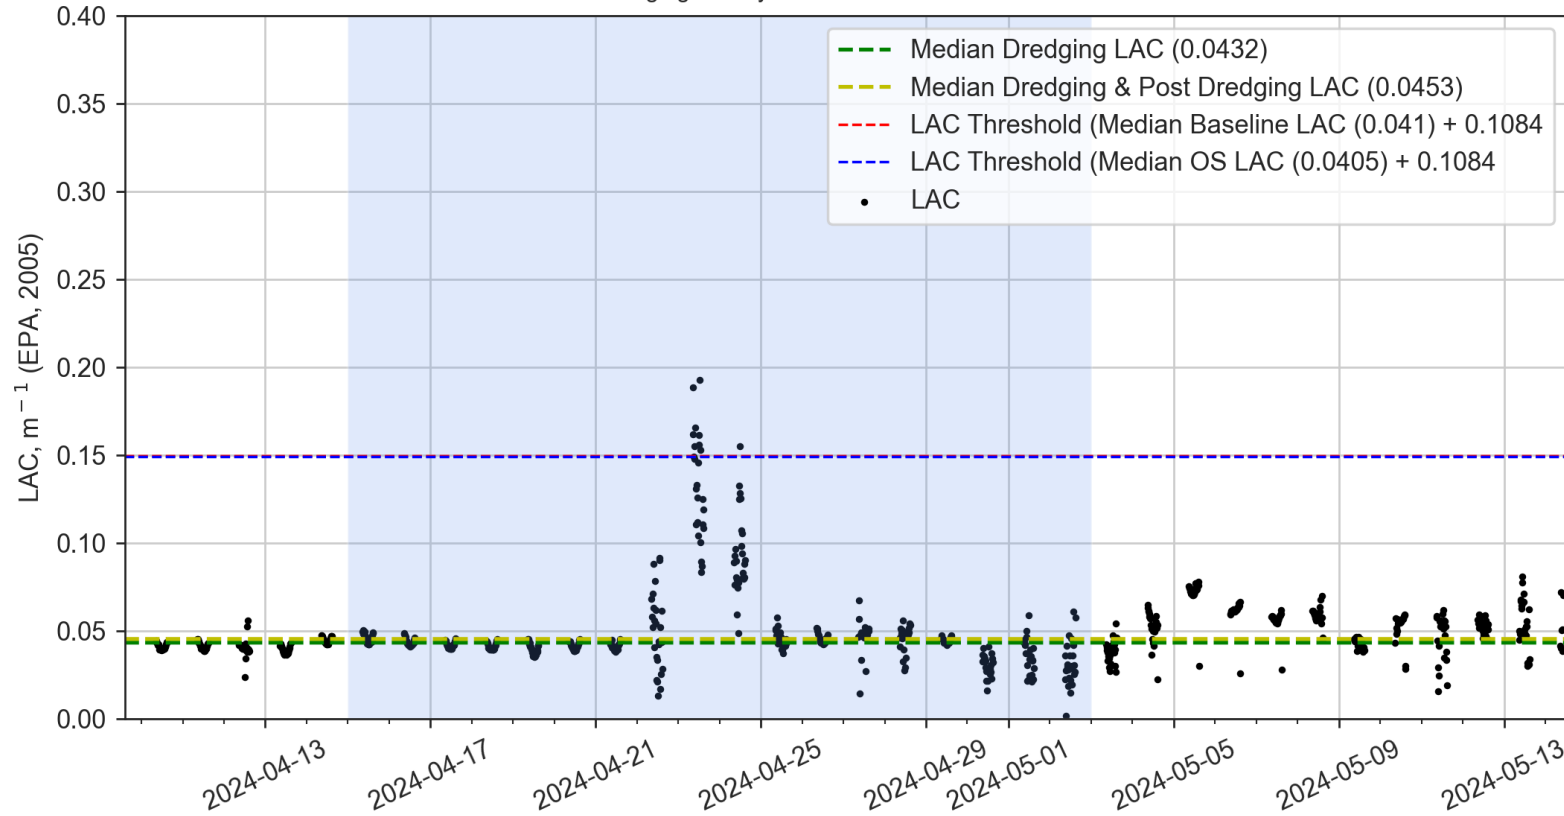
Figure 17: Median LAC threshold at Impact site DI2 during the monitoring period
